Manhole Inspection Summary

Manhole # S17QQ1031MH

Insp Date: **11/15/06 7:54 AM**

Location Address: **5112 YELLOWWOOD AVE**

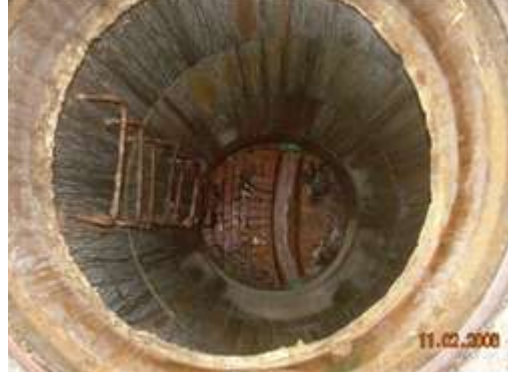
Top View

Corroded steps. Evidence of surcharge - Bench debris.

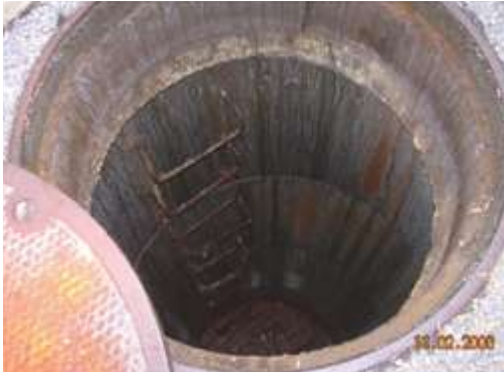
Defect

☒ **Leaks**

Infiltration: ☐ None ☒ **Joint** ☐ Cracks ☐ Mortar ☐ Roots ☒ **Wall**

Frame leaks. Adjustment deterioration and infiltration. Corbel infiltration.

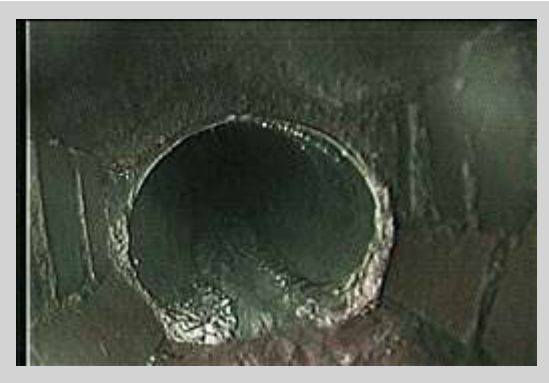
8 in. Circular Gravity Sewer Pipe Out @ 12 O'Clock

Deposits: ☐ None ☐ Mud ☐ Sludge ☐ Debris ☒ Grease

Silt Depth: **0.5** (in.) Deposits Extent: **Light**

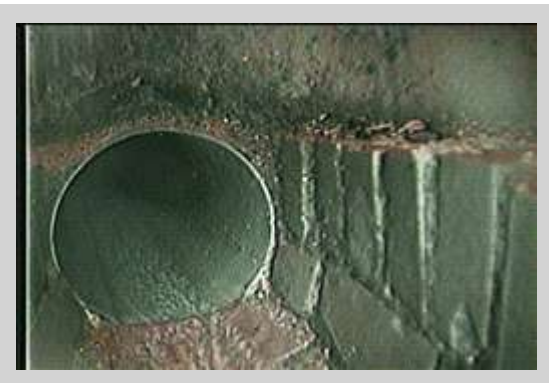
8 in. Circular Gravity Sewer Pipe In @ 5 O'Clock

Infiltration: **Evidence** Pipe Seal Cond: **Unknown**
